Technical Brief

Uneven Wear in Marine Slow-Speed 2-Stroke Engines

TB028

Inadequate Cylinder Oil Supply Due to Undersized Lubricator Piston

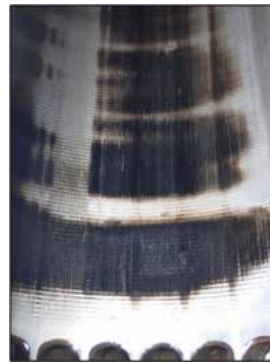
An instance from Gulf Marine's Cylinder Oil Optimisation Program involved an engine fitted with a scrubber system and operating on High Sulphur Fuel Oil (HSFO). The issue was initially detected when elevated iron content was repeatedly observed in Scrape Down Analysis (SDA) results for Unit #2. Further visual scavenge space inspection revealed abnormal liner wear patterns, with cold corrosion considered a likely cause of the increased iron levels.

During the process of fine-tuning the cylinder oil feed rate, it was also noted that Unit #2's cylinder oil consumption was lower than expected under the Monitoring Operating Program (MOP) compared to other units. A thorough inspection confirmed the absence of external leakages, prompting a detailed investigation. It was subsequently discovered that the lubricator piston for Unit #2 was 0.4 mm smaller in diameter than specified in the SPAF file and compared to other units. With the stroke length unchanged, this reduction in piston diameter resulted in decreased oil delivery per stroke.

The insufficient cylinder oil supply, combined with HSFO operation, limited the neutralisation of acidic condensates and accelerated cold corrosion on the liner surface.

To address the issue, the cylinder oil feed rate factor (FRF) for this unit was adjusted to compensate for the reduced oil delivery. The lubricator piston was subsequently replaced with the correct size, conforming to the engine maker's specifications. Follow-up monitoring confirmed a reduction in iron wear levels, with normal visual condition (as shown below), highlighting the importance of vigilant lubrication management.
